The Failure of an Offshore Platform

by Michael P. Collins, Frank J. Vecchio,

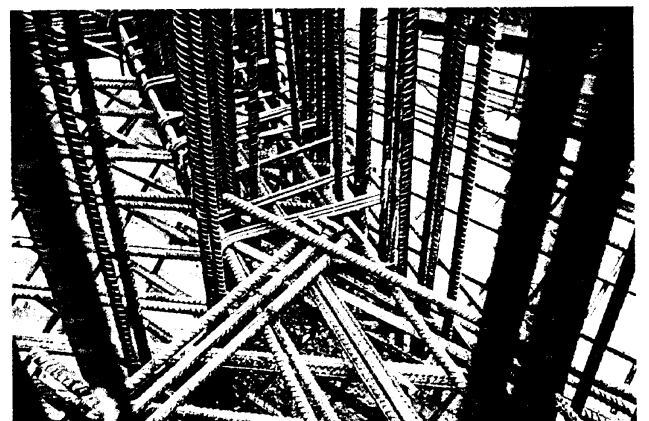
Fig. 8 — Placement of T-headed bars across the throat of the tricell.

Fig. 8 is a photograph of the reinforcing details near the tricell joint taken in June 1990, when the construction had reached the top of the tricell walls. As can be seen, at this location there were stirrups in the tricell walls and three T-headed bars across the throat of the joint.

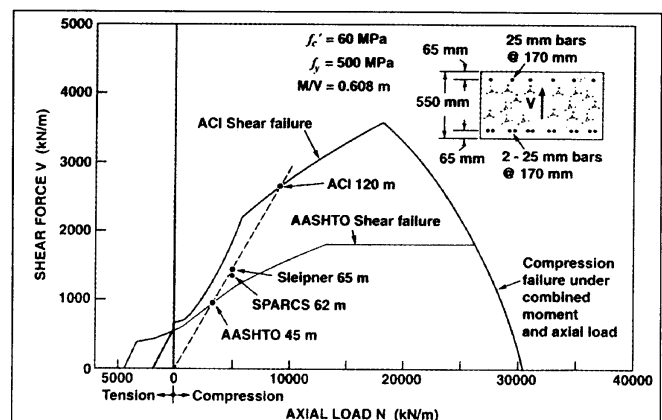
Fig. 12 — Shear force-axial load interaction diagram for the tricell wall of the Sleipner platform.

The failure shear-axial load interaction diagram for the Sleipner tricell wall section calculated using Equations (11-5) to (11-8) of ACI 318-95¹ is shown in Fig. 12. Also shown in this figure is the failure shear-axial load interaction diagram calculated using Section 5.8.3 of the 1994 AASHTO LRFD Specifications.⁸ These AASHTO shear design provisions are based on the modified compression field theory^{9,10} and reflect advances in understanding of shear behavior that have occurred in the last 25 years. It can be seen that while, for this section, the two sets of shear provisions lead to similar estimates of shear strength when the axial load is zero, the predicted changes in shear strength with change of axial load are very different. For the Sleipner tricell wall the axial compression on the wall increased as the shear force increased. In this situation the predicted

failure load is very sensitive to the assumed interaction between shear strength and axial load. As can be seen from Fig. 12, for the Sleipner loading ratios the ACI interaction diagram predicts a failure load corresponding to a 120 m (394 ft) water head, while the AASHTO interaction diagram predicts a 45 m (148 ft) water head at failure.

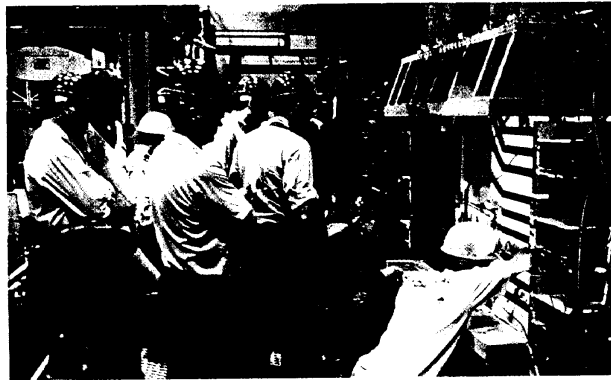
Fig. 13 — Engineers from the Sleipner project team test a specimen representing a portion of the rebuilt platform.

In the six years since the Sleipner failure a large number of experiments¹¹ have been conducted in the University of Toronto's shell element tester¹² to study the response of reinforced concrete wall elements subjected to combined axial compression and shear. Some of these experiments were conducted to assist the engineers involved in the design and construction of the replacement Sleipner platform (Fig. 13). Most of the tests were aimed at identifying appropriate design techniques for reinforced concrete members subjected to compression and shear.

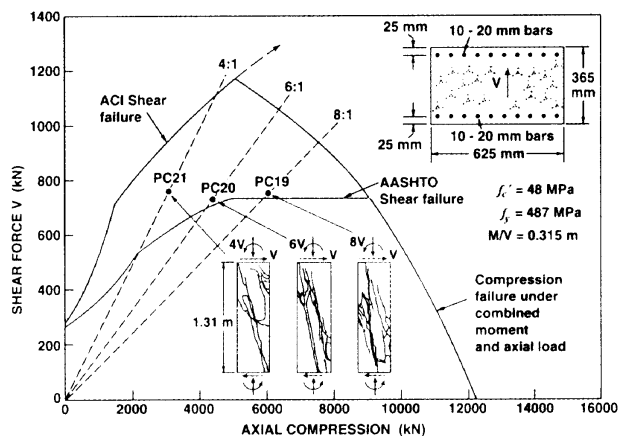
Fig. 14 — Shear force-axial compression interaction diagram for reinforced concrete wall.

The results of one series of tests in which three wall elements, PC19, PC20 and PC21, were loaded at different ratios of axial compression to shear are illustrated in Fig. 14. Also shown in this diagram are the shear strengths for this wall section predicted by the ACI and the AASHTO shear design provisions. It can be seen that the AASHTO predictions are considerably more accurate. Further, while all three of the specimens failed in shear, the ACI pro-

visions predict that specimens PC20 and PC19 would fail in combined flexure and axial load prior to reaching their shear capacities.

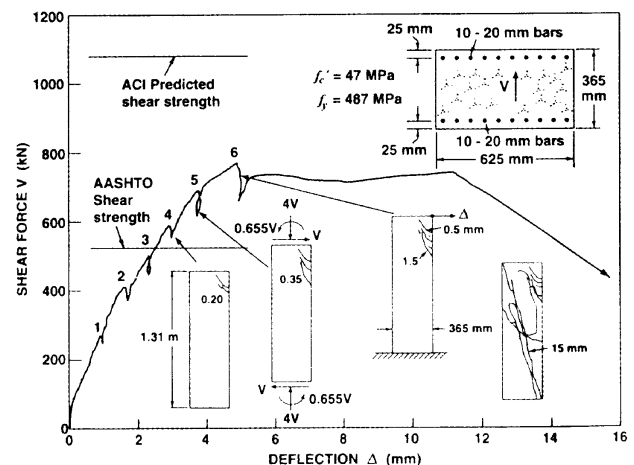
Fig. 15 — Load-deformation response of reinforced concrete wall.

Specimen PC21 was subjected to loading ratios that were reasonably comparable to those experienced by the tricell wall of the Sleipner platform. The observed load-deformation response and crack development for this specimen are recorded in Fig. 15. Flexural cracking was predicted to begin near the ends of the specimen when the applied shear reached about 100 kN (22.5 kips). As the cracking developed there was a substantial reduction in the stiffness of the element resulting in a nonlinear load-deformation response. By the time the shear reached 600 kN (135 kips) — load stage 4 — a number of small diagonal cracks had formed and small expansions of the wall thickness (i.e., bulging of the wall) were recorded. By load stage 6, at a shear of 770 kN (173 kips), the diagonal cracks had reached a width of about 1.5 mm (59 mils) and the wall had increased in thickness by about 0.75 mm (30 mils).

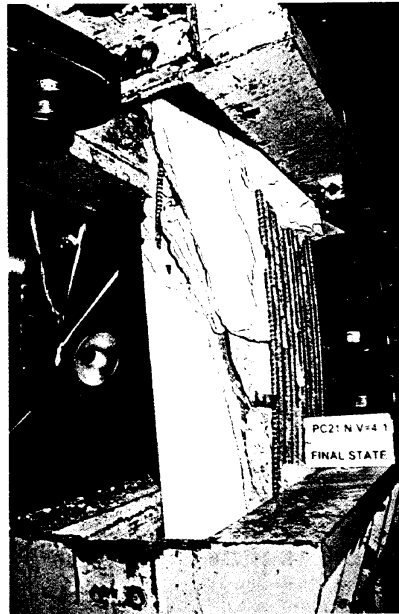
Fig. 16 — Reinforced concrete wall after failure.

While the readings were being taken at load stage 6, the deformation of the specimen was held constant and as a result, the load decreased. When the specimen was reloaded after load stage 6, a loud thud was heard as a sudden shear failure of the wall occurred. A wide diagonal crack formed at about 25° to the longitudinal axis of the member (Fig. 16). It should be appreciated that the formation of such cracks at the ends of the tricell walls in the Sleipner platform would result in the sinking of the structure.
